# Manhole Inspection Summary

Manhole # S33EE\_019MH

**Location** Address: **36 BIDDLE ST**

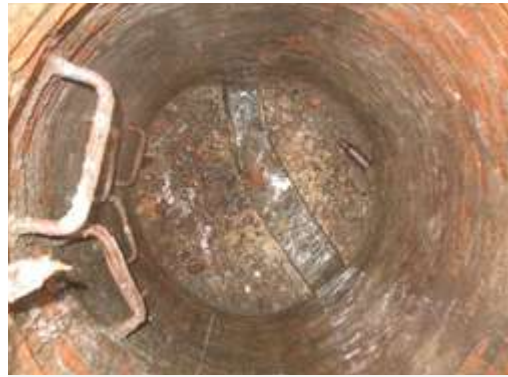
Top View

Corroded and missing steps. Evidence of surcharge - Bench debris. Channel debris.

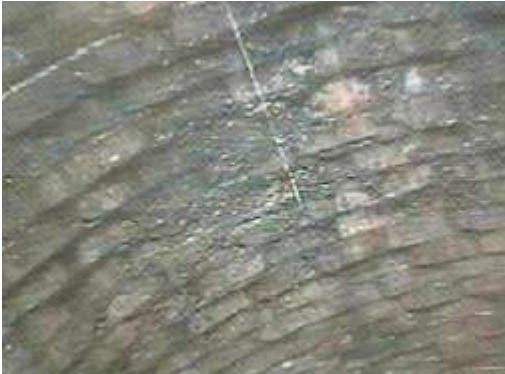
Defect

Adjustment and Corbel infiltration.

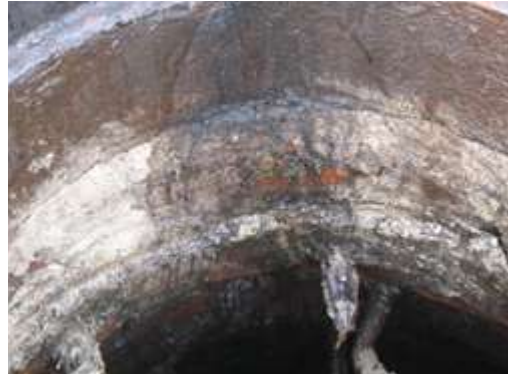
Defect

Frame leaks. Adjustment infiltration.

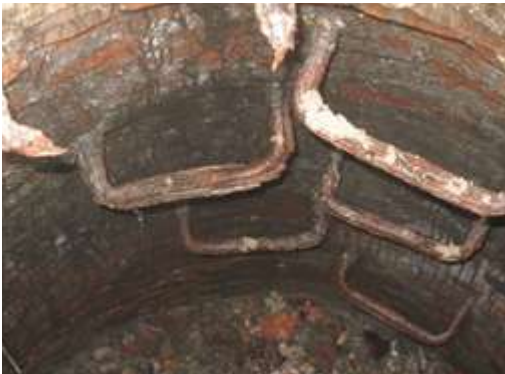
Defect

Corbel and Barrel infiltration. Corroded and missing steps.

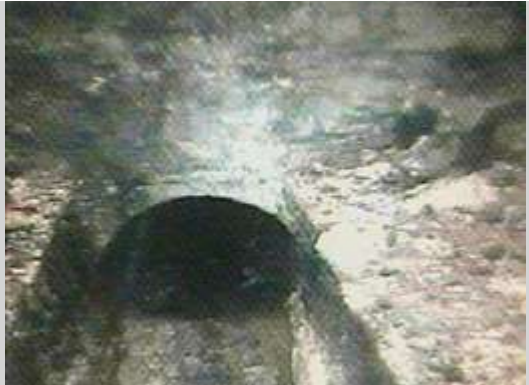
### 8 in. Circular Gravity Sewer Pipe Out @ 12 O'Clock

Deposits: ☐ None ☒ **Mud** ☐ Sludge ☒ **Debris** ☒ **Grease**

Silt Depth: **2** (in.) Deposits Extent: **Light**

Infiltration: **None** Pipe Seal Cond: **Unknown**

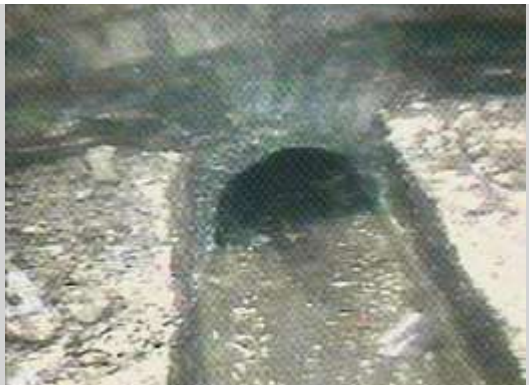
### 8 in. Circular Gravity Sewer Pipe In @ 4 O'Clock

Deposits: ☐ None ☒ **Mud** ☐ Sludge ☒ **Debris** ☒ **Grease**

Silt Depth: **3** (in.) Deposits Extent: **Medium**

Infiltration: **None** Pipe Seal Cond: **Unknown**
